Pest & Termite Inspection Report

1. Description of property inspected

Type:	Domestic	Townhouse
Bedrooms:	4	
Bathrooms:	1	
Ensuites:	1	
Car Park:	Double	
Height:	Two Story	
Building:	Stucco	4
Piers:	-	
Floor:	Timber with concrete areas	
Roof:	Tile	
Age:	2010s	
Image of property:

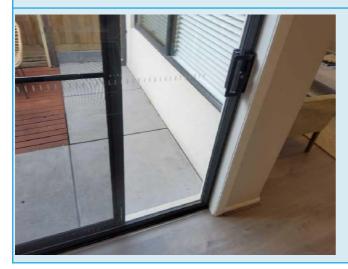
Minor swelling due to damp entry was found to the bottom of sliding door doorjamb. Recommend cleaning out the the sliding door track to allow water to drain to the exterior effectively during rain events.

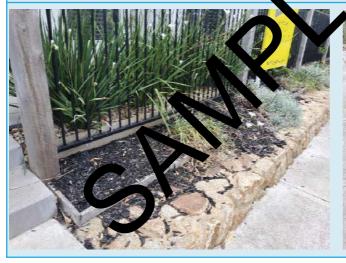
Very minor fungal decay noted to hardwood garden edge to bers at the front of the house.
