AUSTRALIAN PROPERTY &
— BUILDING INSPECTIONS —

Building Inspection Report

Pest & Termite Inspection

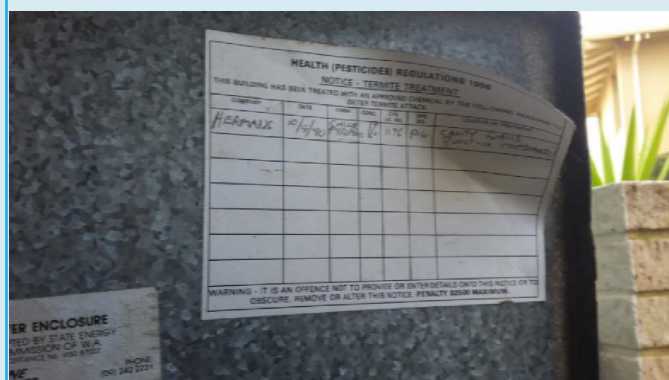
Durable notice located in meter box. Last recorded date of treatment is from 1990.

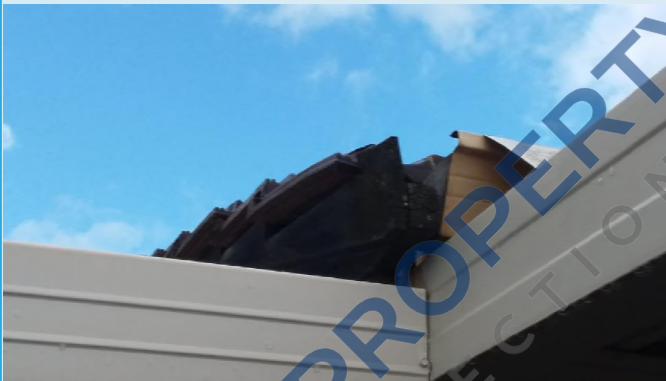
Timber Pest - Findings and Recommendations	
Activity or Damage Advice on Item	Dwelling
Comments	
Wood decay fungi damage to timber barge boards to the dwelling. Recommend repairing or replacing damaged timbers and regular painting as part of an ongoing maintenance program.

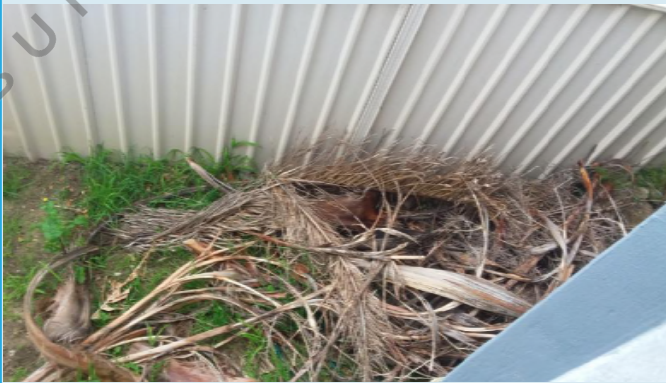
Timber Pest - Findings and Recommendations	
Action Recommended	Grounds
Comments	
Offcuts and pruning stored in the rear yard. Recommend removing prunings as they can provide a food source for termites.

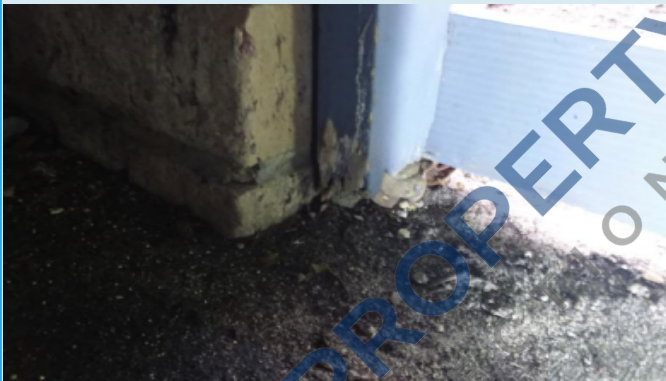
Timber Pest - Findings and Recommendations	
Activity or Damage Advice on Item	Fence line
Comments	
Wood decay fungi damage to bottom of timber posts supporting timber screen fence to the side of the carport. Recommend repairing or replacing damaged timber as required to rectify. Damage appears to be isolated to one end of the structure where there was inadequate drainage and air gap.

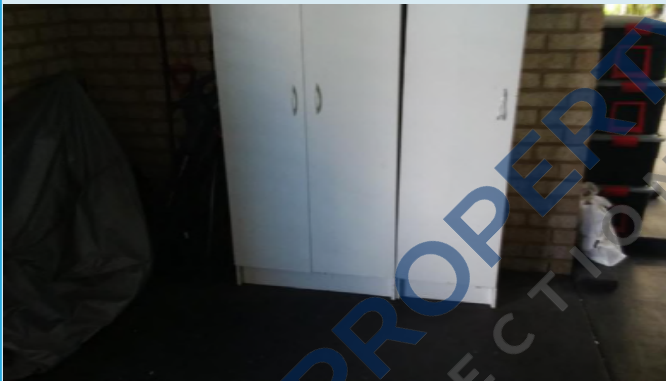
Timber Pest - Findings and Recommendations	
Action Recommended	Garage/Carport
Comments	
<p>Timber based storage cabinet in the carport sitting directly on the ground. Untreated timber in ground contact is conducive to termite activity.</p>

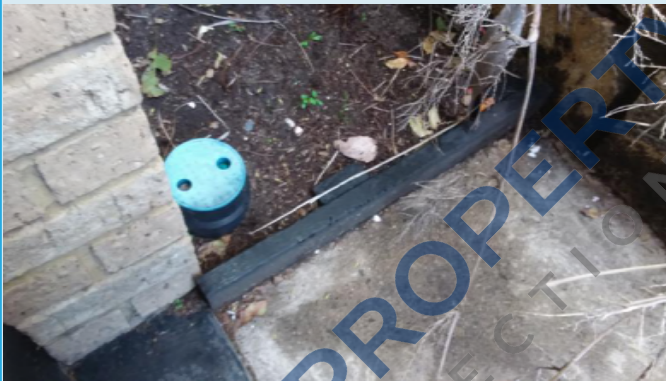
Timber Pest - Findings and Recommendations	
Action Recommended	Garden Borders
Comments	
<p>Timber garden borders to the property appear to be constructed using different types of treated timber. Timber should be treated for pest as well as suitably treated for direct ground contact to prevent wood decay fungi. Recommend replacing any inappropriately treated timbers as required to reduce risk.</p>

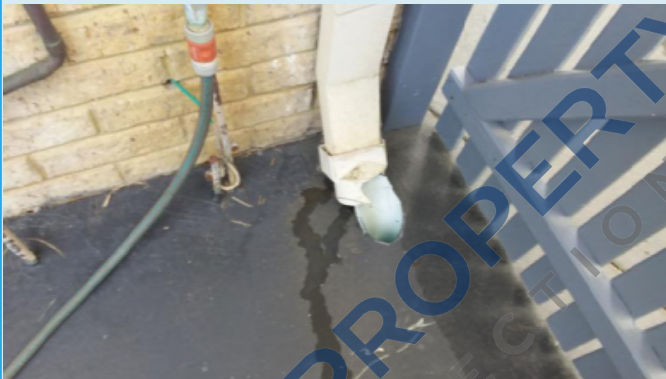
Timber Pest - Findings and Recommendations	
Action Recommended	Dwelling
Comments	
Stormwater pipe was observed to be damaged. Recommend repairing damaged stormwater pipe to Direct storm water away from the property as excess moisture is conducive to termite activity.

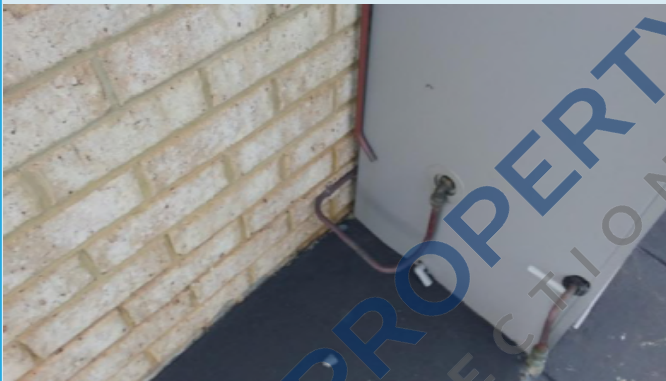
Timber Pest - Findings and Recommendations	
Action Recommended	Dwelling
Comments	
<p>Overflow pipes to hot water systems and air conditioning units should be connected to a drain. Excess moisture to the ground is conducive to termite activity.</p>

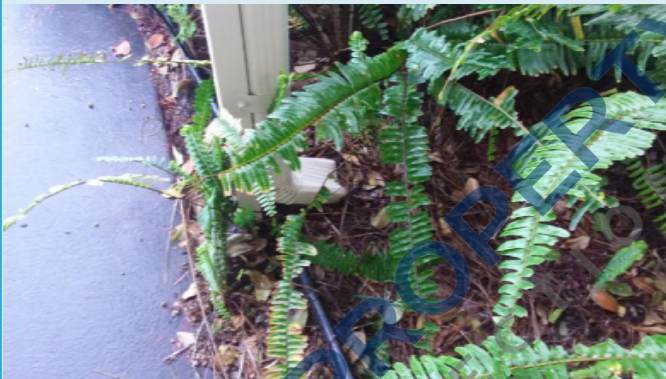
Timber Pest - Findings and Recommendations	
Action Recommended	Dwelling
Comments	
Downpipes to the side patio are not all connected to a stormwater catchment system. Downpipes should be connected to stormwater catchment system to direct water to a controlled point as excess moisture to the ground is conducive to termite activity.
