# New Building Inspection Report - Completion Stage

New Building Inspection - Completion Stage

**New Building Inspection Report - Completion Stage**

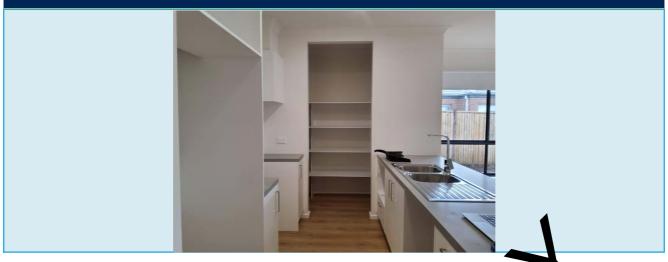
# 6. Kitchen

Kitchen	
Minor and/or Major Defect	Walls
Comments	
Touchup paint walls where scratched or marked, i.e stove	area.
. (	
and the second se	
Kitchen	
Minor and/or Major Defect	Cabinets / trawers
Comments	
Rectify cabinet panel edge, slight chip to edge.	
C AR

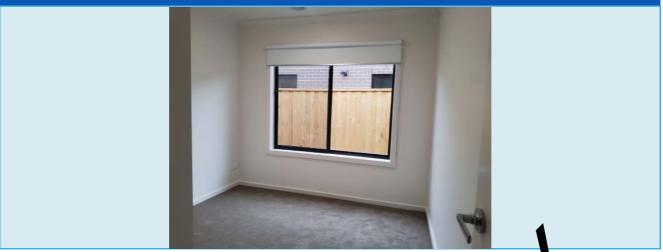
# 8.4. Bedroom 4

Condition Visually Fine	Minor and/or Major Defect	Incomplete Item	Unable to Inspect Dua 'o Access	Not Applicable (N/A)
Floor					
Walls	 ∑			S	
Ceilings	đ				
Doors		V	7		
Windows	J				
Robes	V				
Smoke Detectors	ď				
Bedroom 4			•		
Minor and/or Major De	fect		oors		
Comments					
Repair small chip in corner of a robuloc					
Repair small chip in corner of a barded

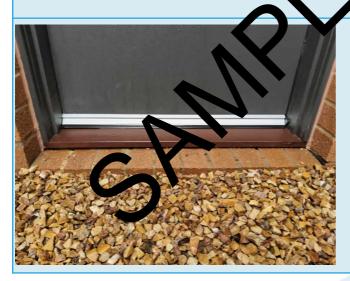
Seal the gap between garage rear door tread and ill bricks to prevent water entry to the cavity.

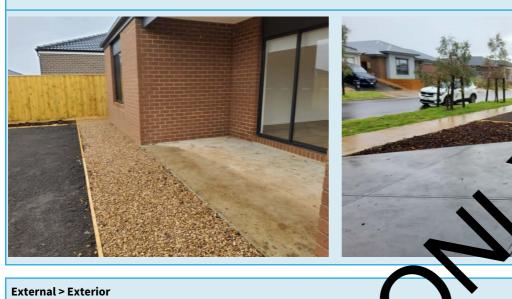
Final clean to patio, driveway and entry path areas.

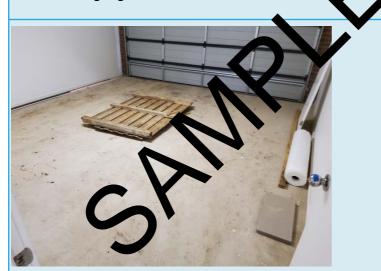
Final clean to garage floor area.

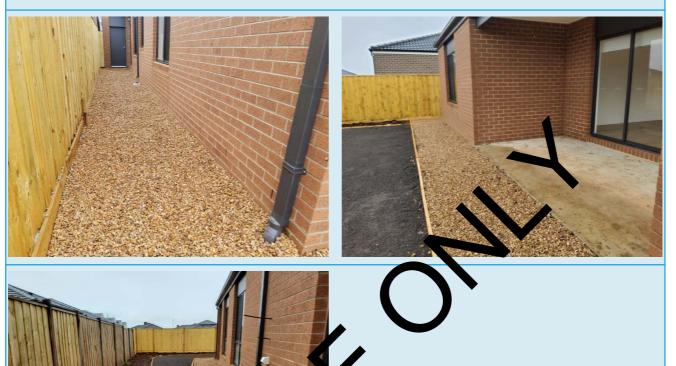
No drainage pits are visible for surface water drainage around the house. Install drainage pits as per engineers specifications if not installed, with finished ground surface graded to these.

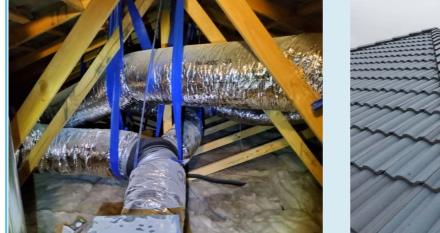
# 12. External of property > Roof areas

Minor and/or Major Defect	Roof
Comments	
Replace several cracked tiles at the front and front	left side.
External > Roof Areas	
Minor and/or Major Defect	Roof
Comments	
Slide a few uneven tiles into correct position over the	he gutter
CO CO

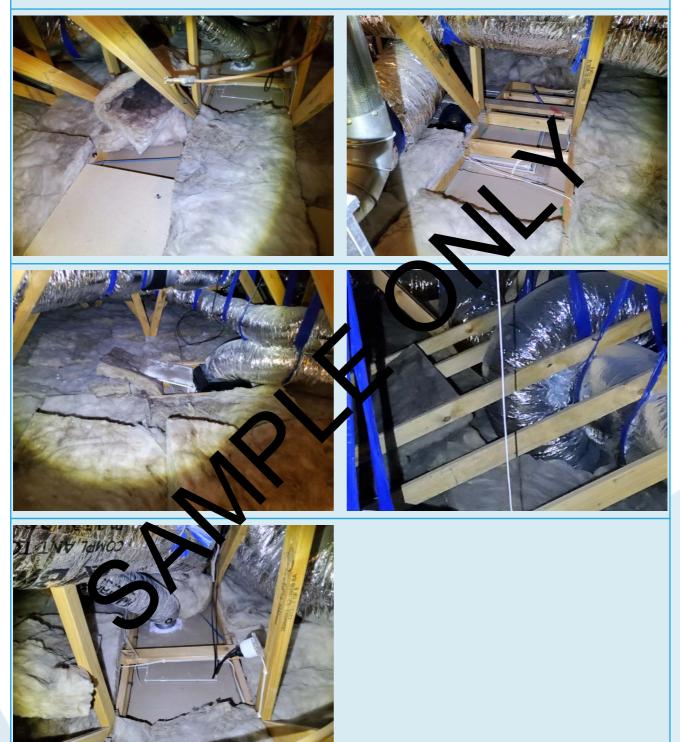
Replace insulation batts where they have been moved alongside ducts, to comply with BCA energy efficiency requirements.
