Building Inspection Report

Type of Report: Pre-Auction Building Inspection

Type:	Domestic	Townhouse
Bedrooms:	2	
Bathrooms:	1	
Ensuites:	-	
Car Park:	Single	
Height:	Two Story	
Building:	Brick Veneer	
Piers:	-	
Floor:	Timber with concrete areas	
Roof:	Metal	
Age:	-

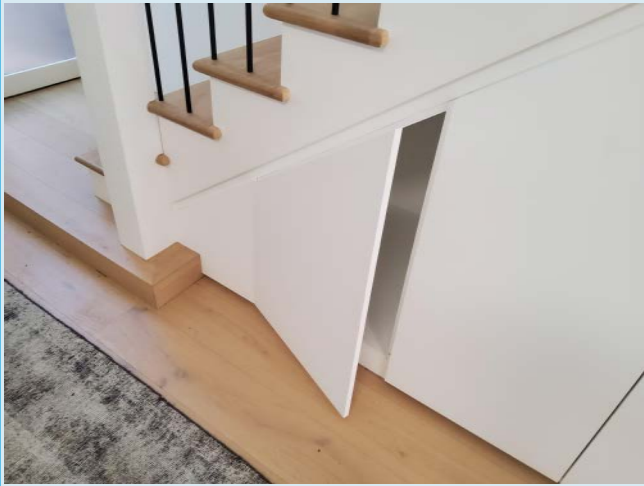
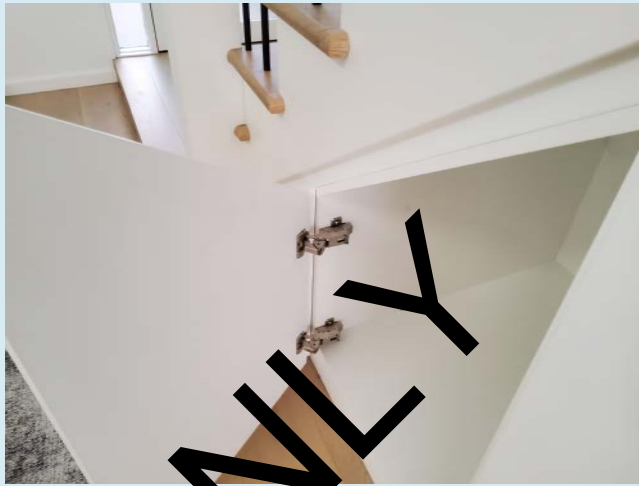
Kitchen	
General Advice/Minor Defect	Cabinets / Drawers
Comments	
Adjust cabinet door hinge so a door below the steps closes properly.

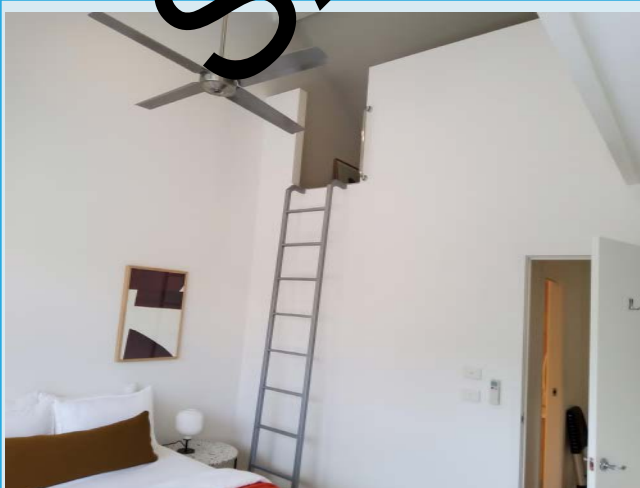
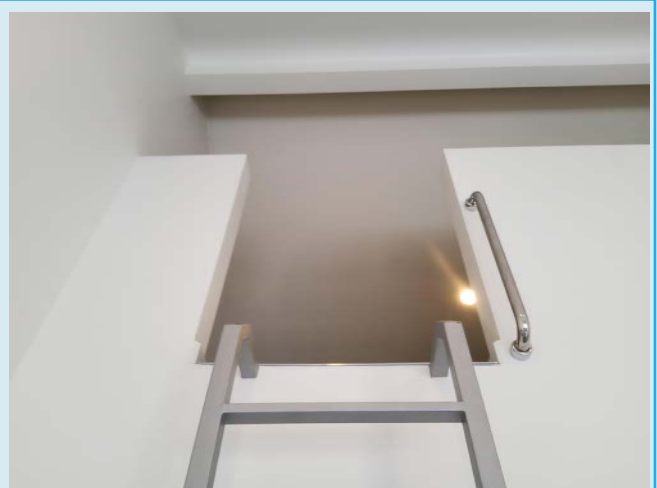
Bedroom 1	
General Advice/Minor Defect	Ceilings
Comments	
<p>Very slight crack noted to plaster alongside a roof beam. Loft area walls and walls throughout have been painted and appeared visually fine for the age and type of construction. There was no evidence of water damage or leaks.</p>

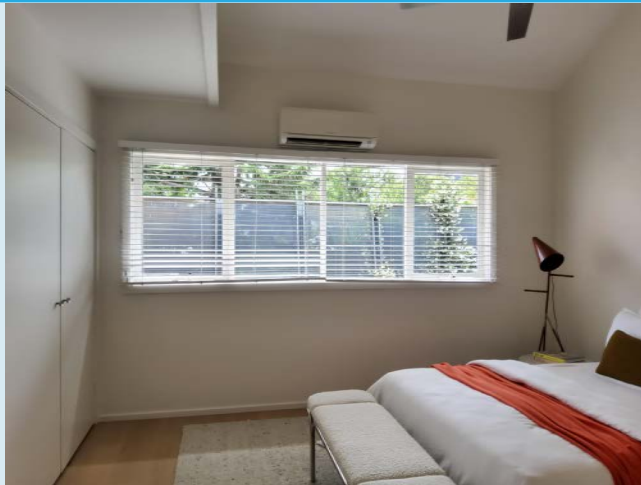
Window was jamming open. Recommend replacing the winder mechanism. Contact a handyman service.

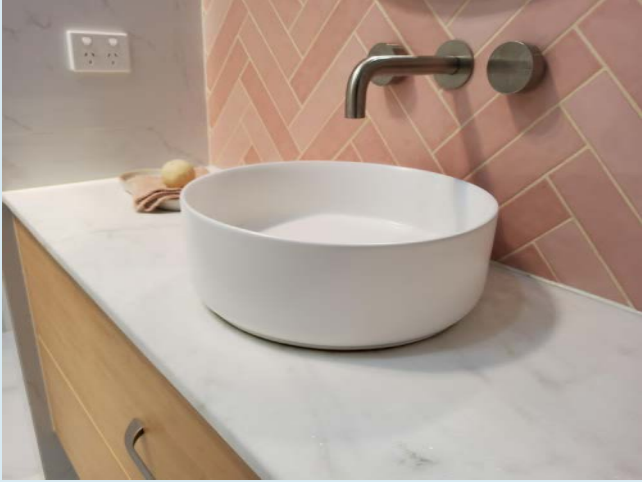
Bathroom 1	
General Advice/Minor Defect	Sealants
Comments	
Recommend installing sealant around the basin to prevent possible damp damage to cabinetry below.

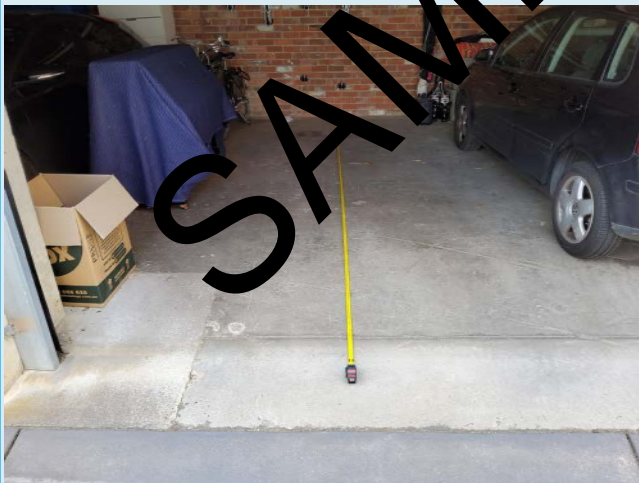
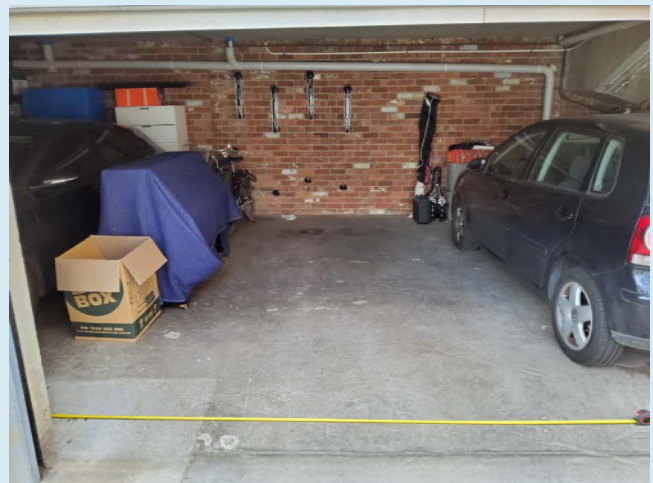
General advice - garage approximate length is 5.1m from the roller door to the back wall, and approximate width is 5.4m (double car space width from the right side wall to midline of the concrete pillar. Note it is single car space on the agents plan, so the approximate width would be 7m. Please refer to the contract or advice from your conveyancer for exact sizes).

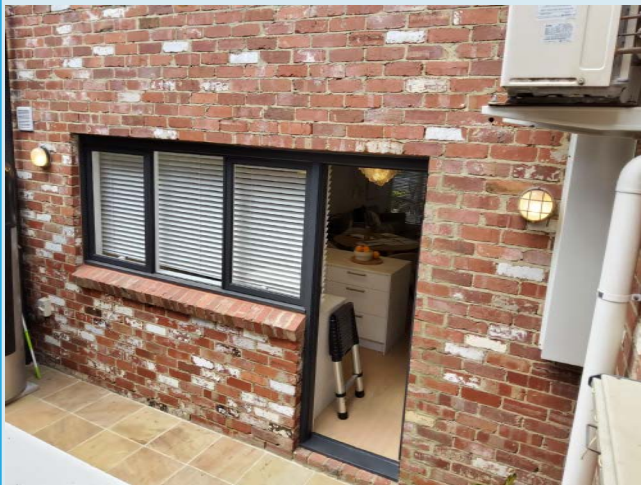
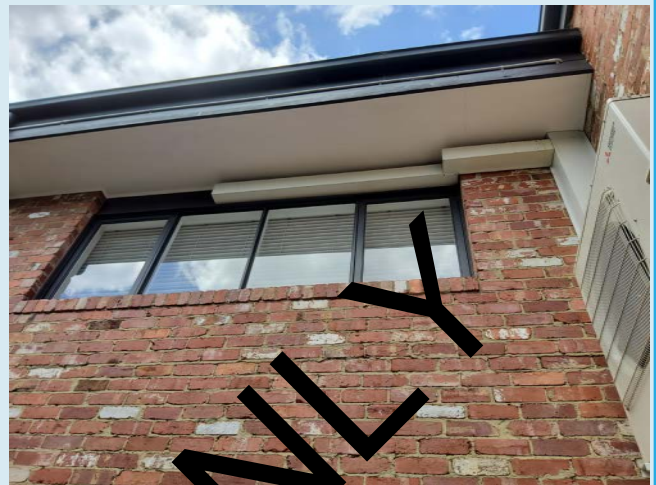
No evidence of major structural defects was found to walls of the townhouse.

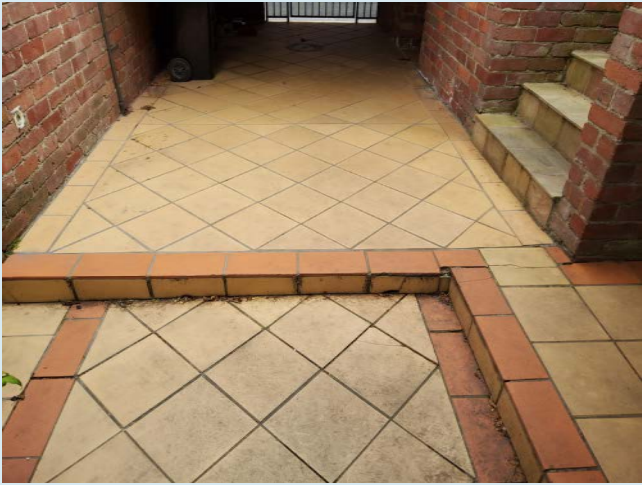
External > Exterior	
General Advice/Minor Defect	Driveways and Paths
Comments	
Slight cracks noted to common area pathway pavers.

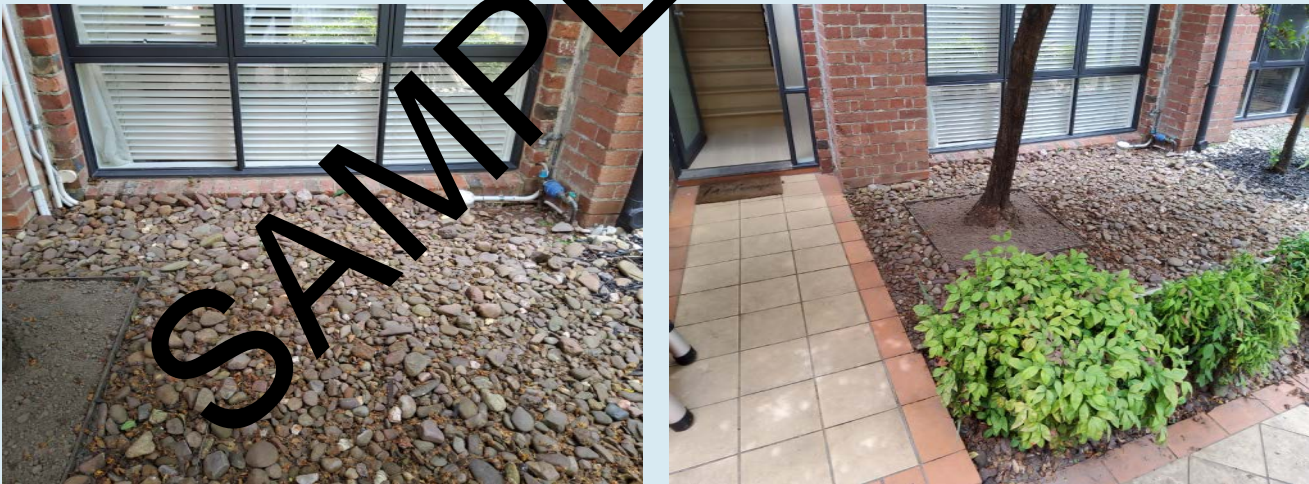
External > Exterior	
General Advice/Minor Defect	Site Drainage
Comments	
There is a drainage riser pipe in the front yard, but no drainage pit. Recommend a plumber be engaged to grade the ground surface to a drainage pit and the stormwater drainage system, to minimise the risk of possible movement of footings and consequent damage to walls over time from regular rainwater seepage around the footings.

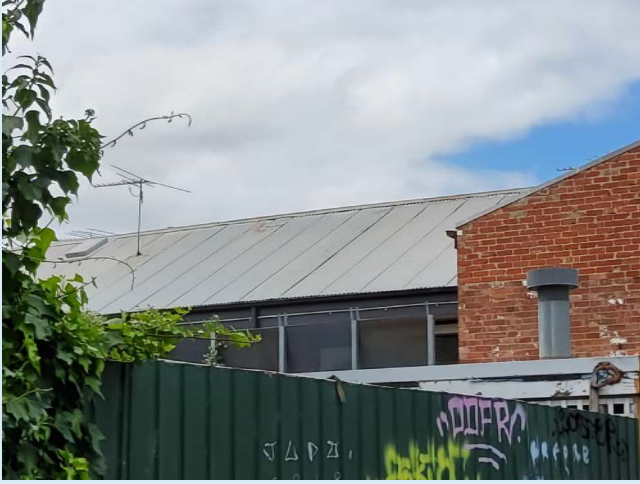
External > Roof Areas	
Unable to Inspect Due to Access	Roof
Comments	
Upper level roof was unable to be safely accessed due to safe height restriction over 3.6m from the ground.
