Building Inspection Report

New Building Inspection - Frame Stage

APBI Building Inspection Report

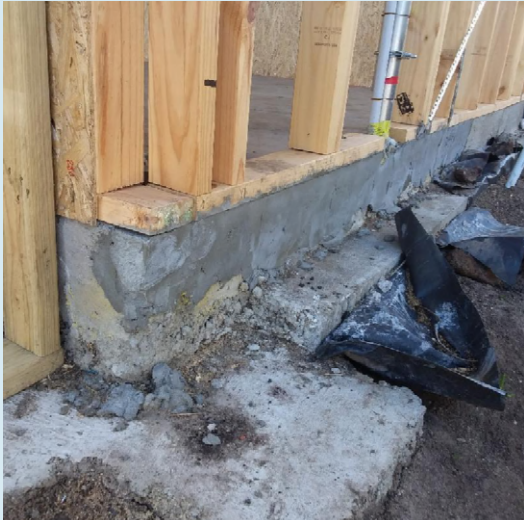
Sub Floor/Slab	
General Advice on Item	Slab
Comments	
Slab edge has been extended in several areas with a non shrink grout or similar to ensure wall plates are fully supported. No further action is required.

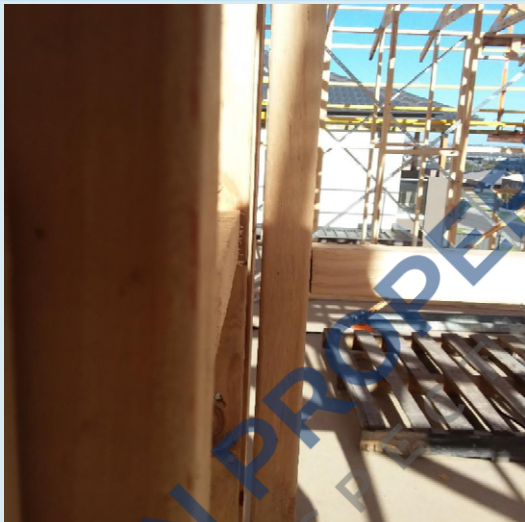
Walls and Structural Beams	
Repair Recommended	Support Points
Comments	
Supporting studs are required under beam supporting front 2nd storey wall in entrance way.

Walls and Structural Beams	
General Advice on Item	Walls
Comments	
<p>Wall junctions have not been nailed off at time of inspection however this is typically completed at lock up stage when straightening of walls is completed and will be assessed at lock up stage inspection.</p>

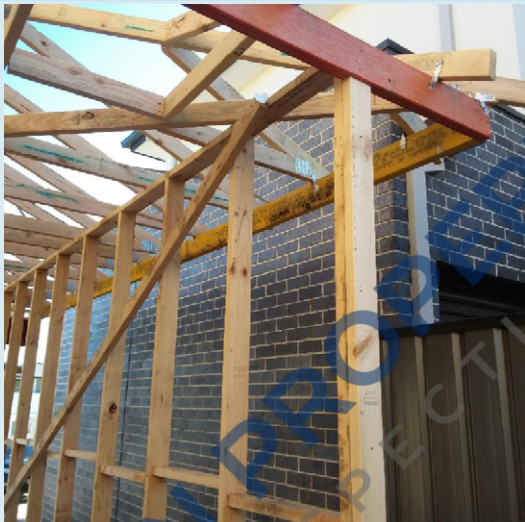
Walls and Structural Beams	
Repair Recommended	Walls
Comments	
<p>Several window trims and plates have been removed to allow for scaffolding. This will require re-installation once scaffolding has been dismantled and when windows are installed.</p>

Walls and Structural Beams	
General Advice on Item	Support Points
Comments	
<p>A temporary stud wall has been erected in the garage to support roof structure prior to brickwork being completed. Builder to ensure all point loads are adequately supported by brickwork and we will assess this at lock up stage inspection if accessible.</p>

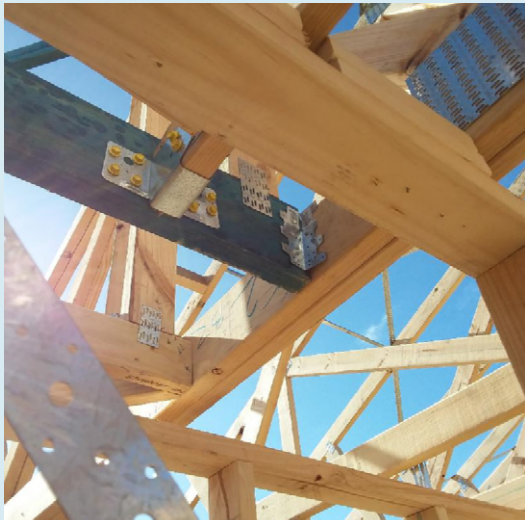
Roof	
General Advice on Item	Brackets Fixings
Comments	
<p>J1 truss connects into TG2 with a triple grip securing in position, I believe this bracket needs upgrading, builder to confirm with truss manufacturer what the appropriate bracket on this connection is to be.</p>
